# **Corrugated Iron Buildings in Britain: Cultural Significance and Conservation Challenges**

Volume II

Degree of Doctor of Philosophy in Architecture

The University of Edinburgh

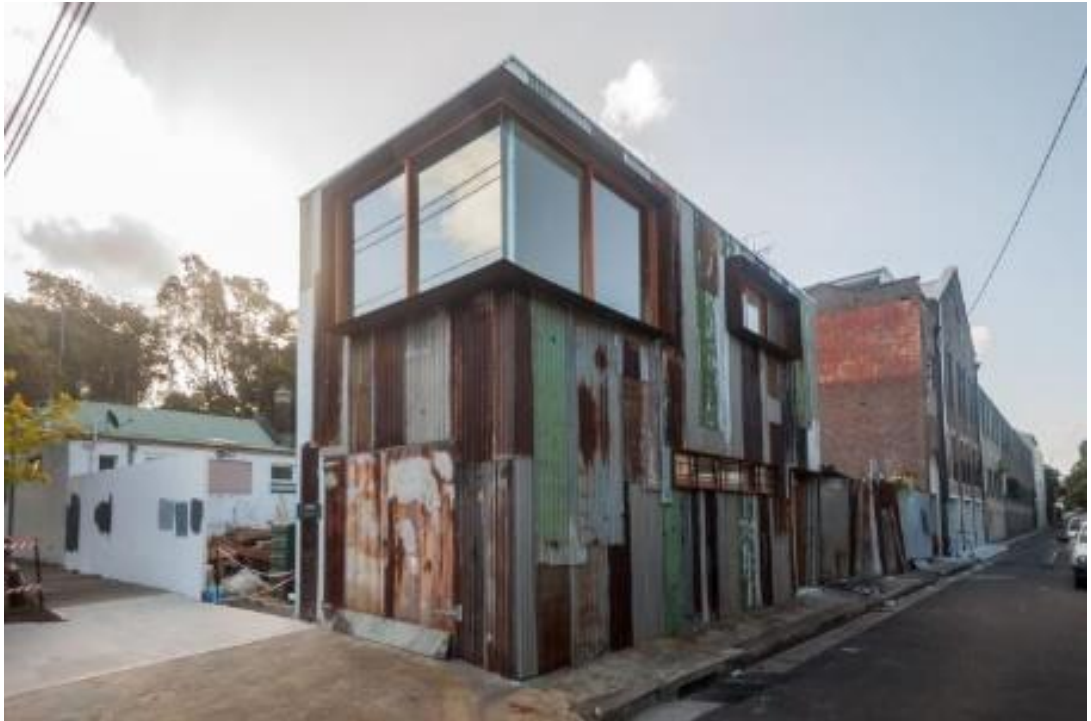
Figure 3.12. 'Tinshed,' Australia, designed by Raffaello Rosselli. In an unusual decision, Rosselli has used the material in its broken and battered form. Apparently, when the builders finished the initial build, he felt it was not battered enough and adjusted the sheet of corrugated iron to make it look wobblier. Perhaps it should be no surprise that this exciting use of corrugated iron is being created in Australia. Image reproduced with permission.

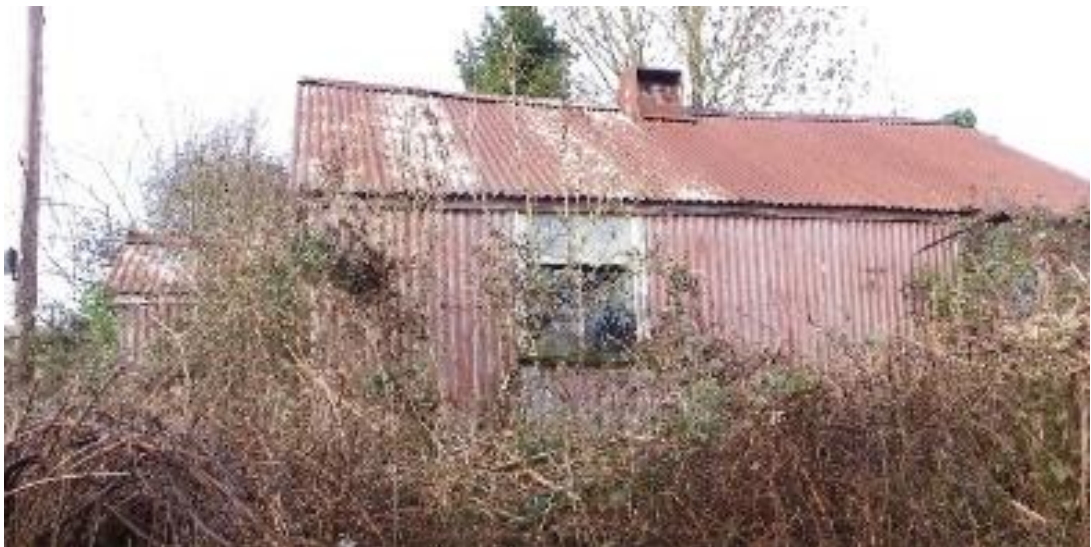
Figure 3.14. An abandoned corrugated iron chapel at Rodhuish in Somerset. Its designation and at-risk status is unknown, but if it remains unoccupied and unmaintained its life expectancy is very limited in this condition. Photograph by the author.

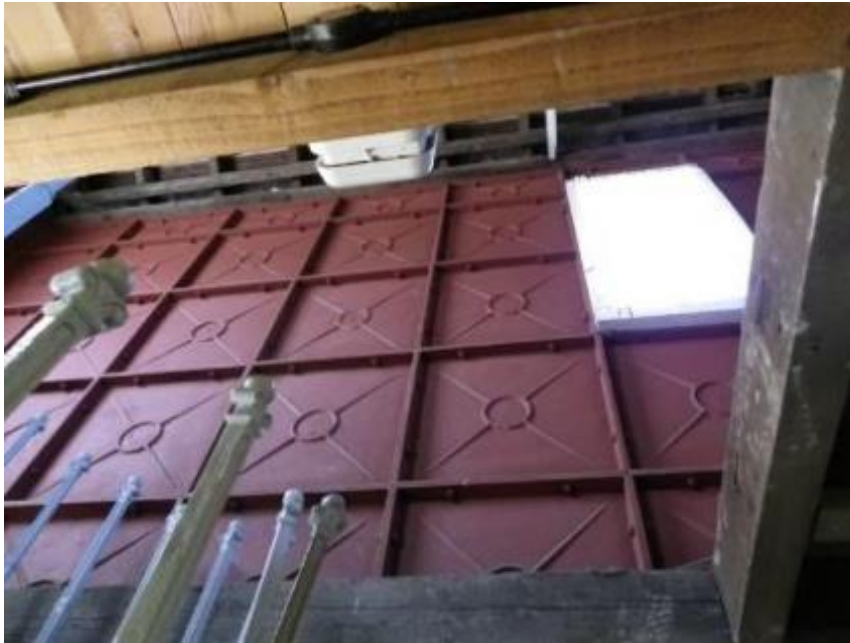
Figure 4.3. The wall of a house at the Black Country Museum – made from cast iron tiles. Metal buildings have never been as economical to building compared with other materials.

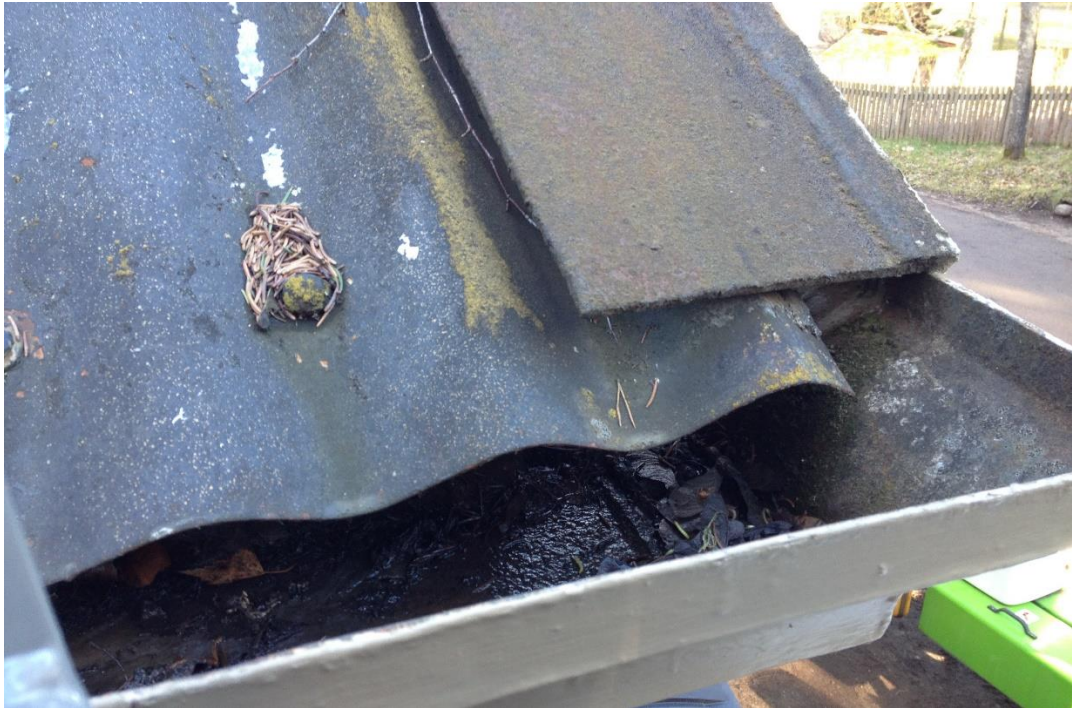
Figure 4.10. Balmoral ballroom guttering. Photograph by the Factor of Balmoral, 2014.

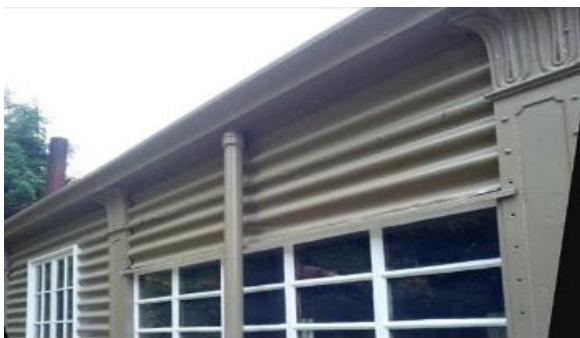
Figure 4.12. The integral cast iron guttering system. Functioning as designed, as are the replacement downpipes. The empty bolt holes in the cast iron column to the right of the image are worthy of note, as they are where the original corrugated iron has been removed to form a modified window.

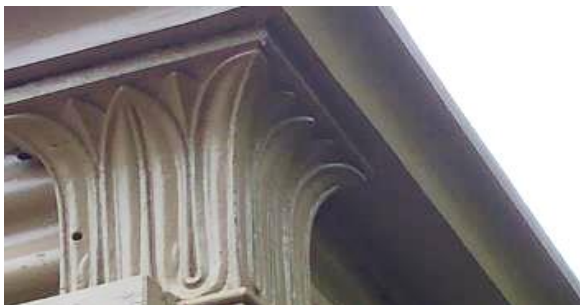
Figure 4.13. Frame detail of the ballroom. The frame has no significant decay problems and has good paint adhesion.

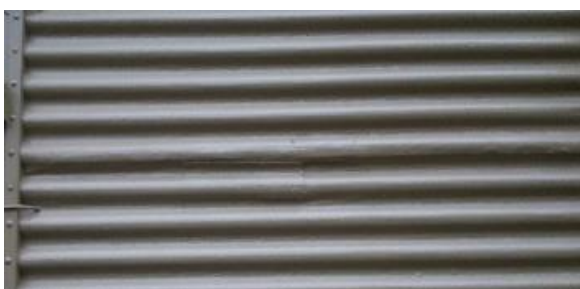
Figure 4.14. Original wrought iron corrugated panels on the walls. In generally excellent condition with only light surface corrosion pitting. This suggests that paint film maintenance has not always been consistent.

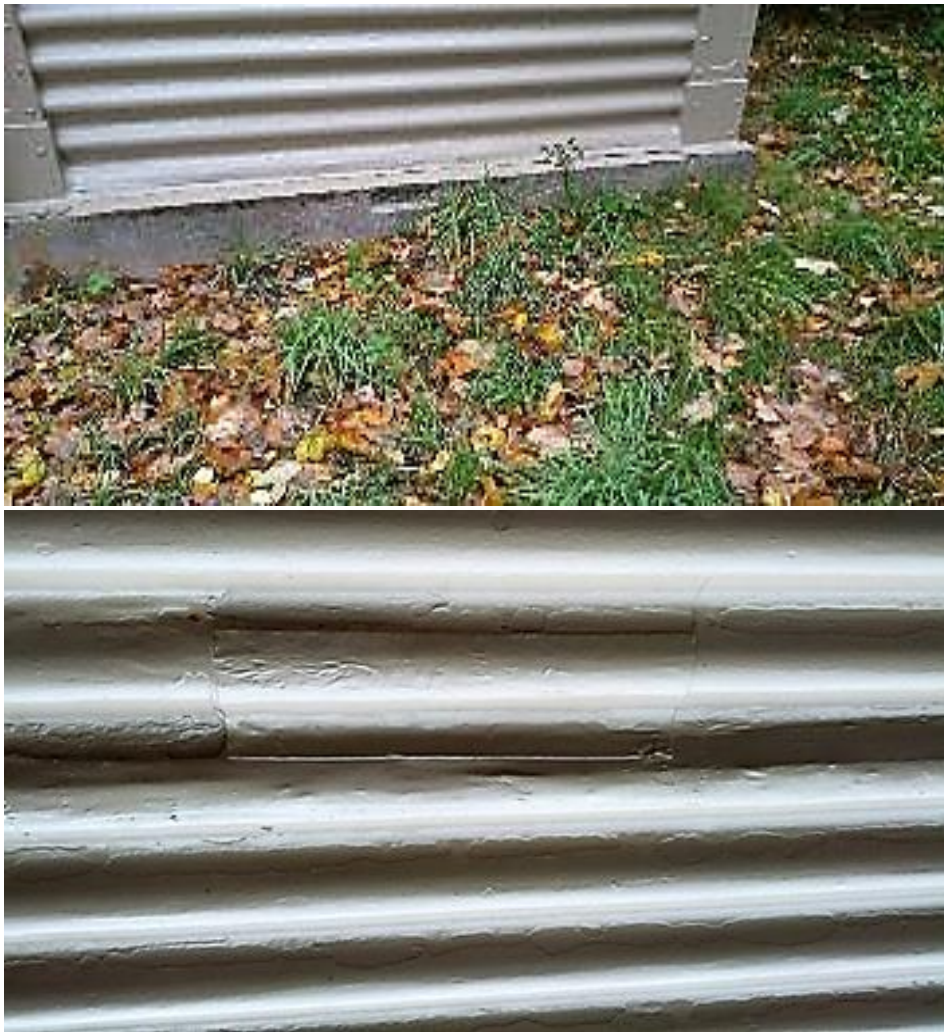
Figures 4.18 and 4.19. Repairs to corrosion damage using glass fibre reinforced resin. Though skilfully done, the change in surface texture caused by these repairs is noticeable. Against these disadvantages resin repair is cheap and highly weather resistant in the short and medium term. It is relatively easy to remove and retreat and allows the maximum retention of historic material. Balancing the pros and cons of conservation strategies is rarely straightforward.

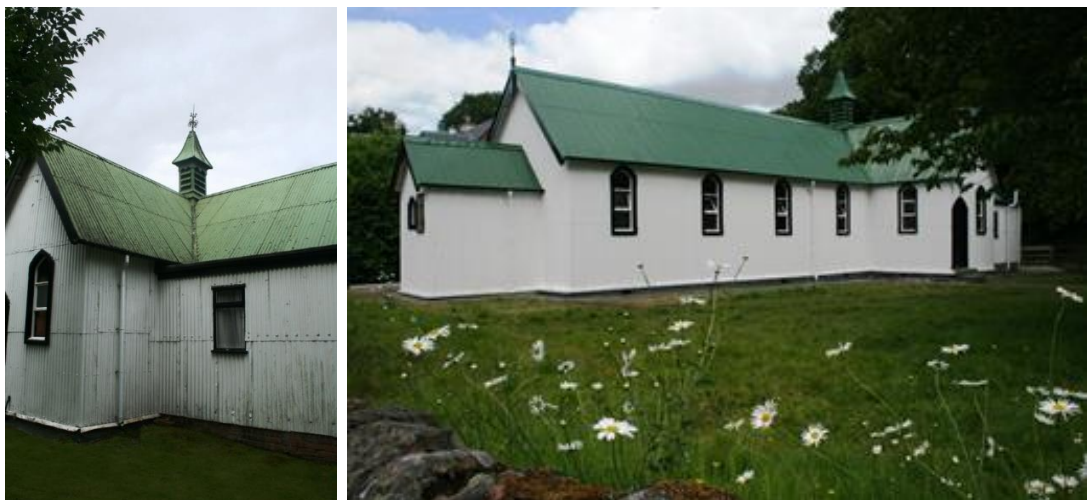
Figure 4.28. A general view of the church before and after repair. Note the dark staining at the lower edge of many sheets of corrugated iron. This is caused by biological growth which is benefiting from moisture trapped in the lap of the sheets. It is a sign that the corrugated iron is not seating well and is allowing moisture penetration. The general dowdiness indicates that the paint needs renewal. Photograph by Sonya Linskaill.

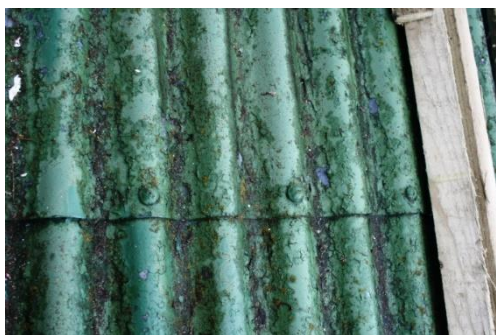
Figure 4.29. Corrosion protection: This image shows the failure of more recent paint on the roof. Although the underlying paint film appears to be largely intact, and there is no evidence that the galvanising has failed, this still needs attention. Most importantly, it looks horrible and is an invitation for any hostile fewer to suggest that the whole building needs demolition. Technically this failed paint is trapping water which is likely to speed up corrosion of the underlying metal. Photograph by Sonya Linskaill.

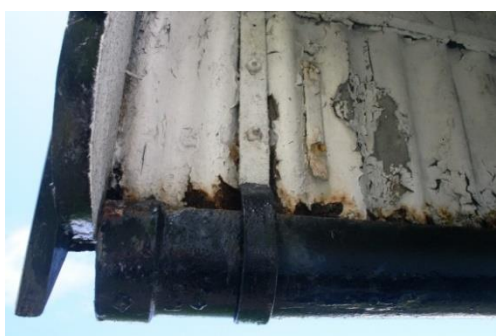
Figure 4.30. The condition of the corrugated iron in the underside of the eaves illustrates the generally poor condition of all the roofing sheets. The only area where repair rather than replacement was deemed impractical was the roof, where there was extensive damage to the corrugated iron. Severe corrosion had taken place at the lower edge where the corrugated iron came into direct contact with the cast iron guttering and its fixings; also damaged by corrosion was the joint between the ridge piece and the roofing sheets. Photograph by Sonya Linskaill.

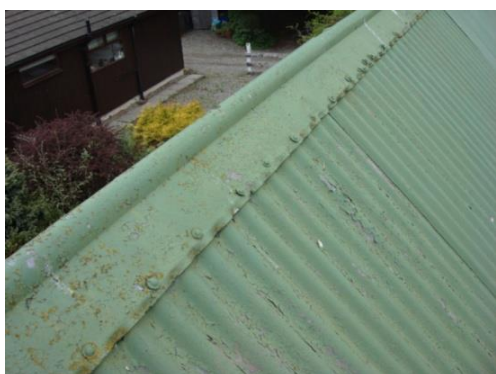
Figure 4.31. Ridge piece (at top of roofing sheets). Dismantling showed that significant amounts of water had entered the roof because of the poor quality of this detail. There is a poorly shaped lap between the ridge piece and the roofing sheets. Photograph by Sonya Linskaill.

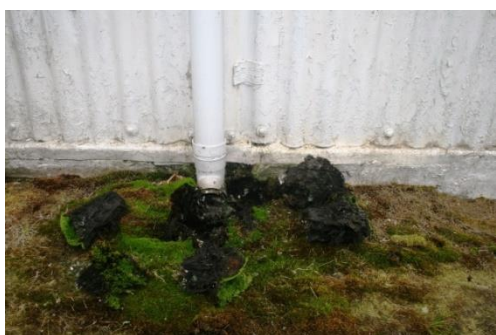
Figure 4.32. Before repair, the downpipes appeared to be working correctly but discharging directly into the soil adjacent to the walls. This was causing excessive moisture to be drawn into the plinth wall, the civil beam of the wooden frame and the lower edge of the corrugated iron, causing them all to decay. Conservation often fails to see beyond the immediate object, but in this case the architect has installed a functioning subsurface drainage system. The drain is now repaired and functioning correctly. An interesting conflict arose between the architect and building control over the proposed installation of a French drain. Such drainage systems are a commonplace in conservation specifications but were not acceptable to the local building control officer. Photograph by Sonya Linskaill.

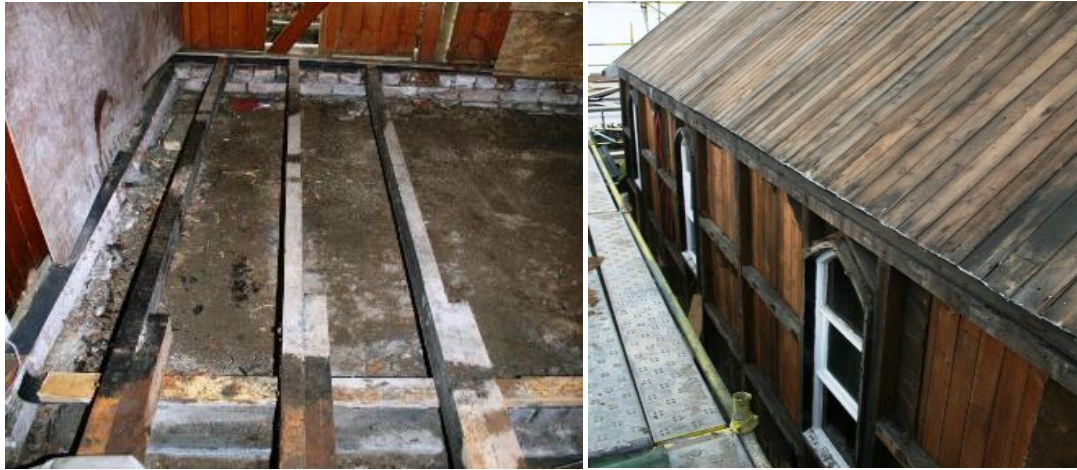
Figure 4.33. Details of wooden frame. St Fillan's follows the standard nineteenth century approach to constructing corrugated iron chapels. This used a wooden frame to support (and be stiffened by) the corrugated iron cladding. In this way an air gap is automatically created between the corrugated sheets and the internal timber boarding. The gap allows ventilation which minimises the build-up of condensation on the inside face of the corrugated iron and thus produces a durable form of construction. Historically, this durability depended largely on the high quality of timber used in the framing. The durability of the wood masked a fundamental problem: corrugated iron sheeting is inherently prone to accumulate condensation on its inner surface. The quality of wood currently available to repair the original framing does not match that of the original. Photographs by Sonya Linskaill.

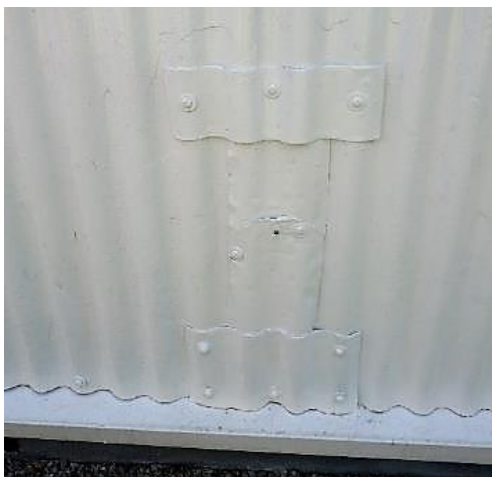
Figure 4.40. Patch repairs are nailed to the original corrugated iron. These appear to have been done at some considerable time in the past. It is not clear how well they have been waterproofed all-weather matching corrugated iron for the patches was obtained. They do, however, appear to be working satisfactorily. The conservation approach to the repair at St Fillan's has not chosen to make good pre-existing repairs, but to retain them. Photograph by Sonya Linskaill.

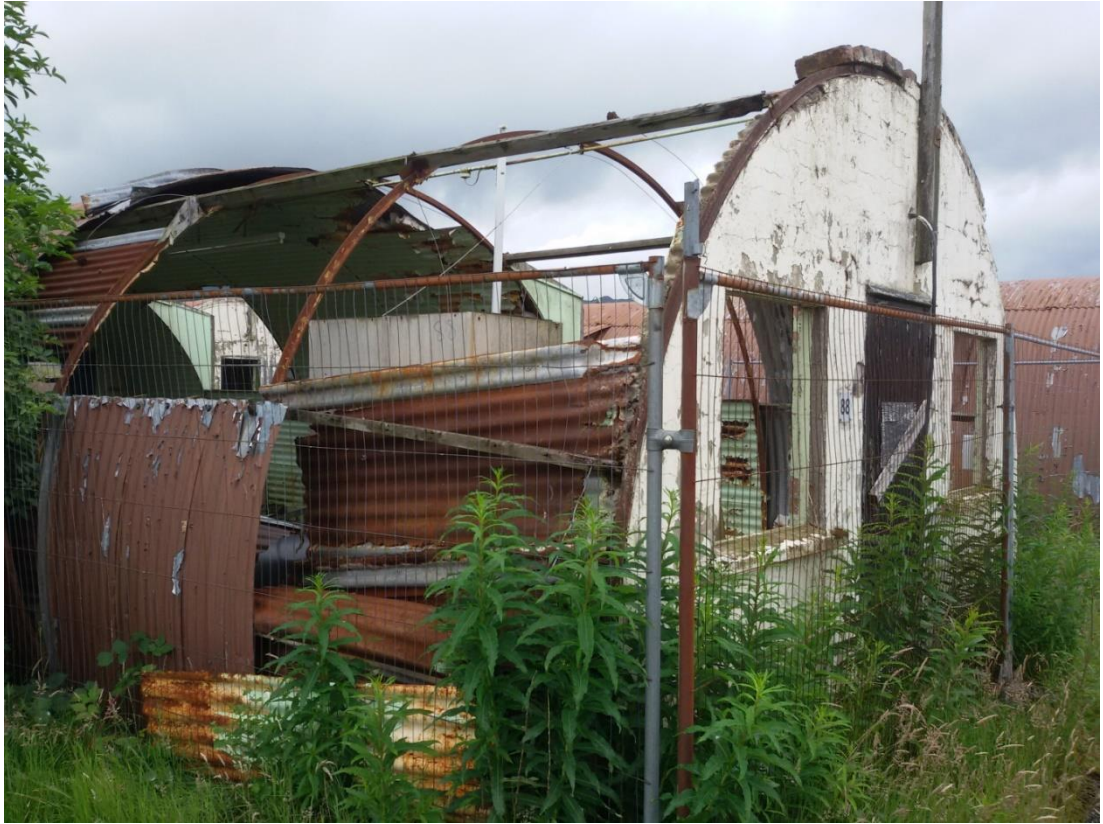
Figure 4.50. The poor condition of many of the huts, partly due to the quality of the materials used. The steel and the galvanising are likely to have been compromised because of wartime shortages, and because the buildings were only seen as temporary. Photograph by the author.

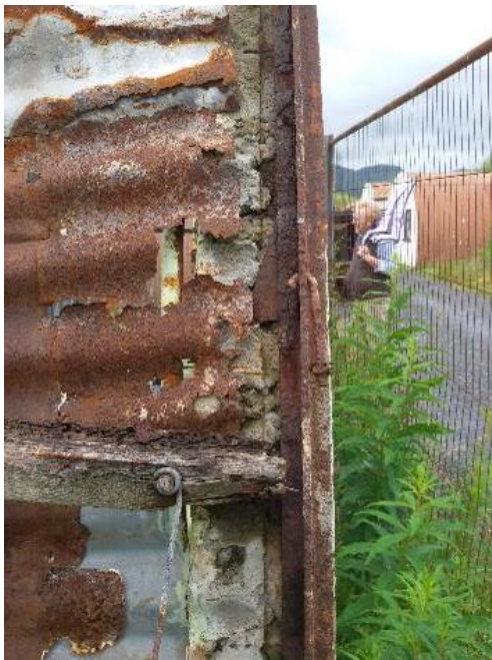
Figure 4.53. A further vulnerability of the basic design is the termination of the corrugated iron at the end walls. This has yet to be satisfactorily addressed. Water penetrating along and through the end wall is trapped between the masonry and the corrugated iron causing rapid decay of the metal. Photograph by the author.

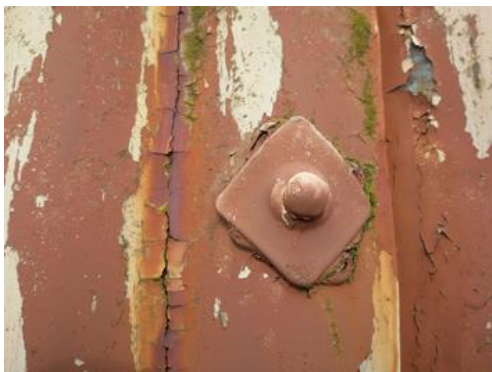
Figure 4.54. Though not the case here, fixings generally are a source of water ingress. Thermal expansion of the corrugated iron is a real problem, and fixings have to be flexible enough to accommodate this without coming loose. This is a major challenge and the fixings frequently fail in the long term. Photograph by the author.

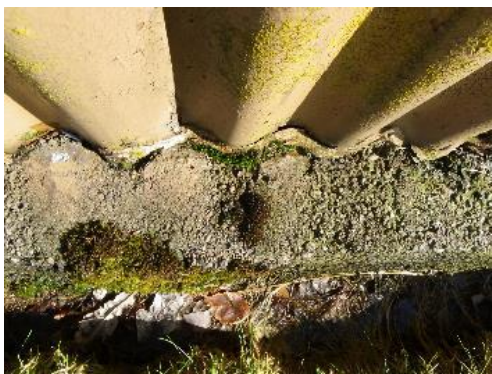
Figure 4.58. One major problem, found on many of the huts, is the reinforcement of the lower edges of the corrugated iron with bricks and concrete. This has been poorly executed and is trapping water between the concrete and the metal which will accelerate corrosion of the corrugated iron. Photograph by the author.

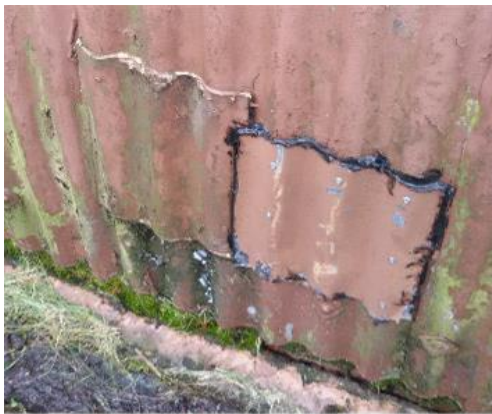
Figure 4.60. Patch repairs are attractive from a conservation point of view because they involve the minimum loss of original material. Here, however, they depend on the cannibalising of other huts to obtain the patch material and the use of potentially corrosive metal fittings to secure the patch. Adding a sealant to make the patch waterproof is essential, but there is no reason to do it as unattractively as this. Photograph by the author.
